3.6 Flora

3.6.1 Pre-Construction Translocation

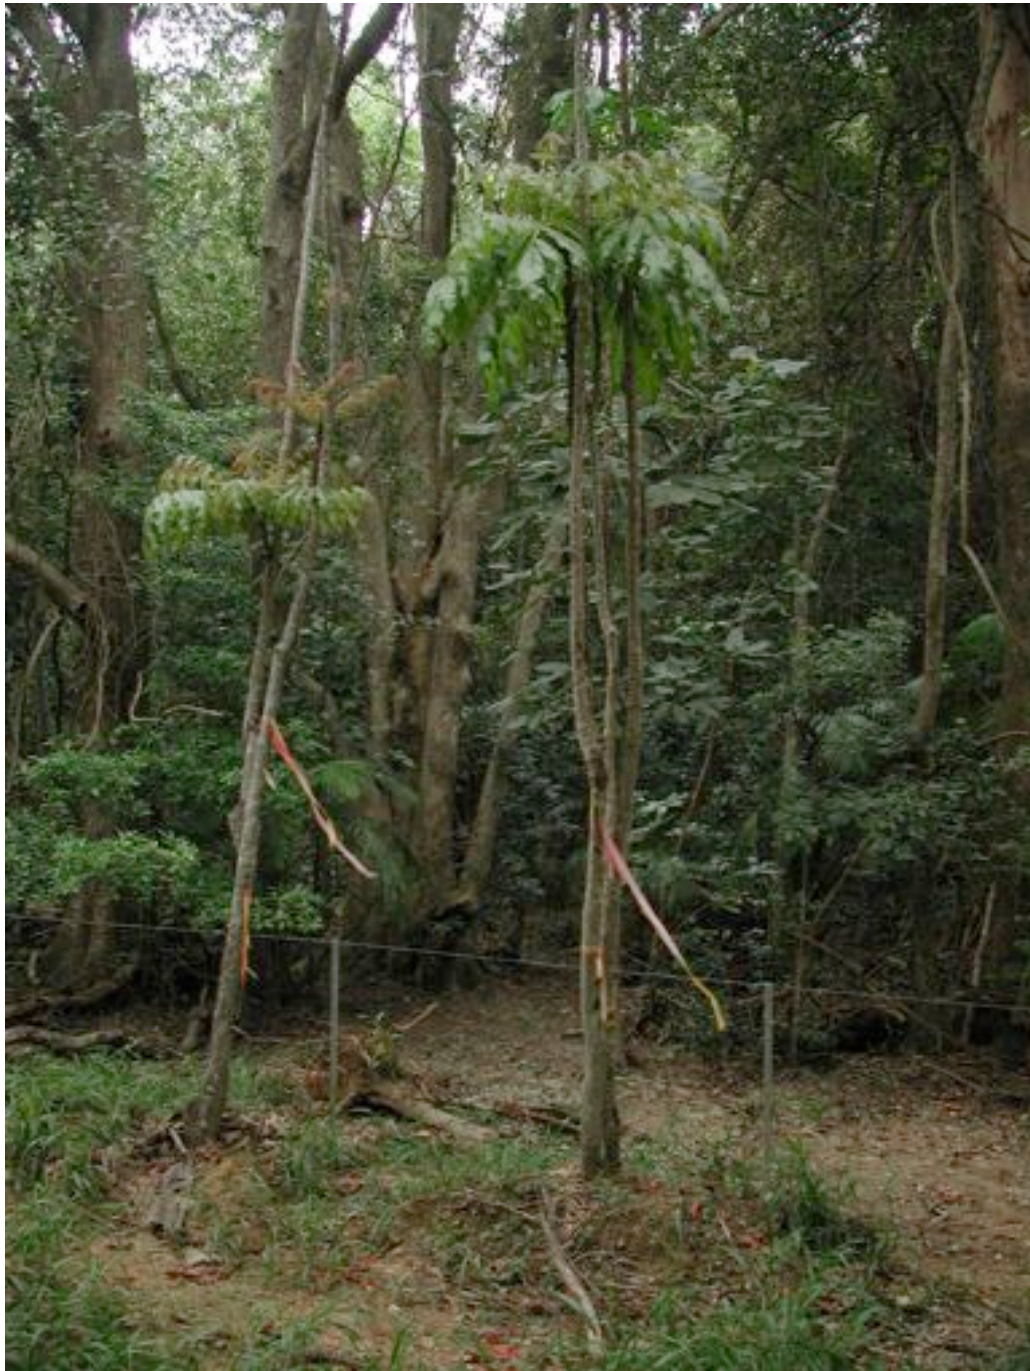
Photograph 3.18 Translocation area with translocated species marked with red tape for ongoing monitoring. The area has been fenced to prevent grazing by wallabies and to demarcate the translocation management area.

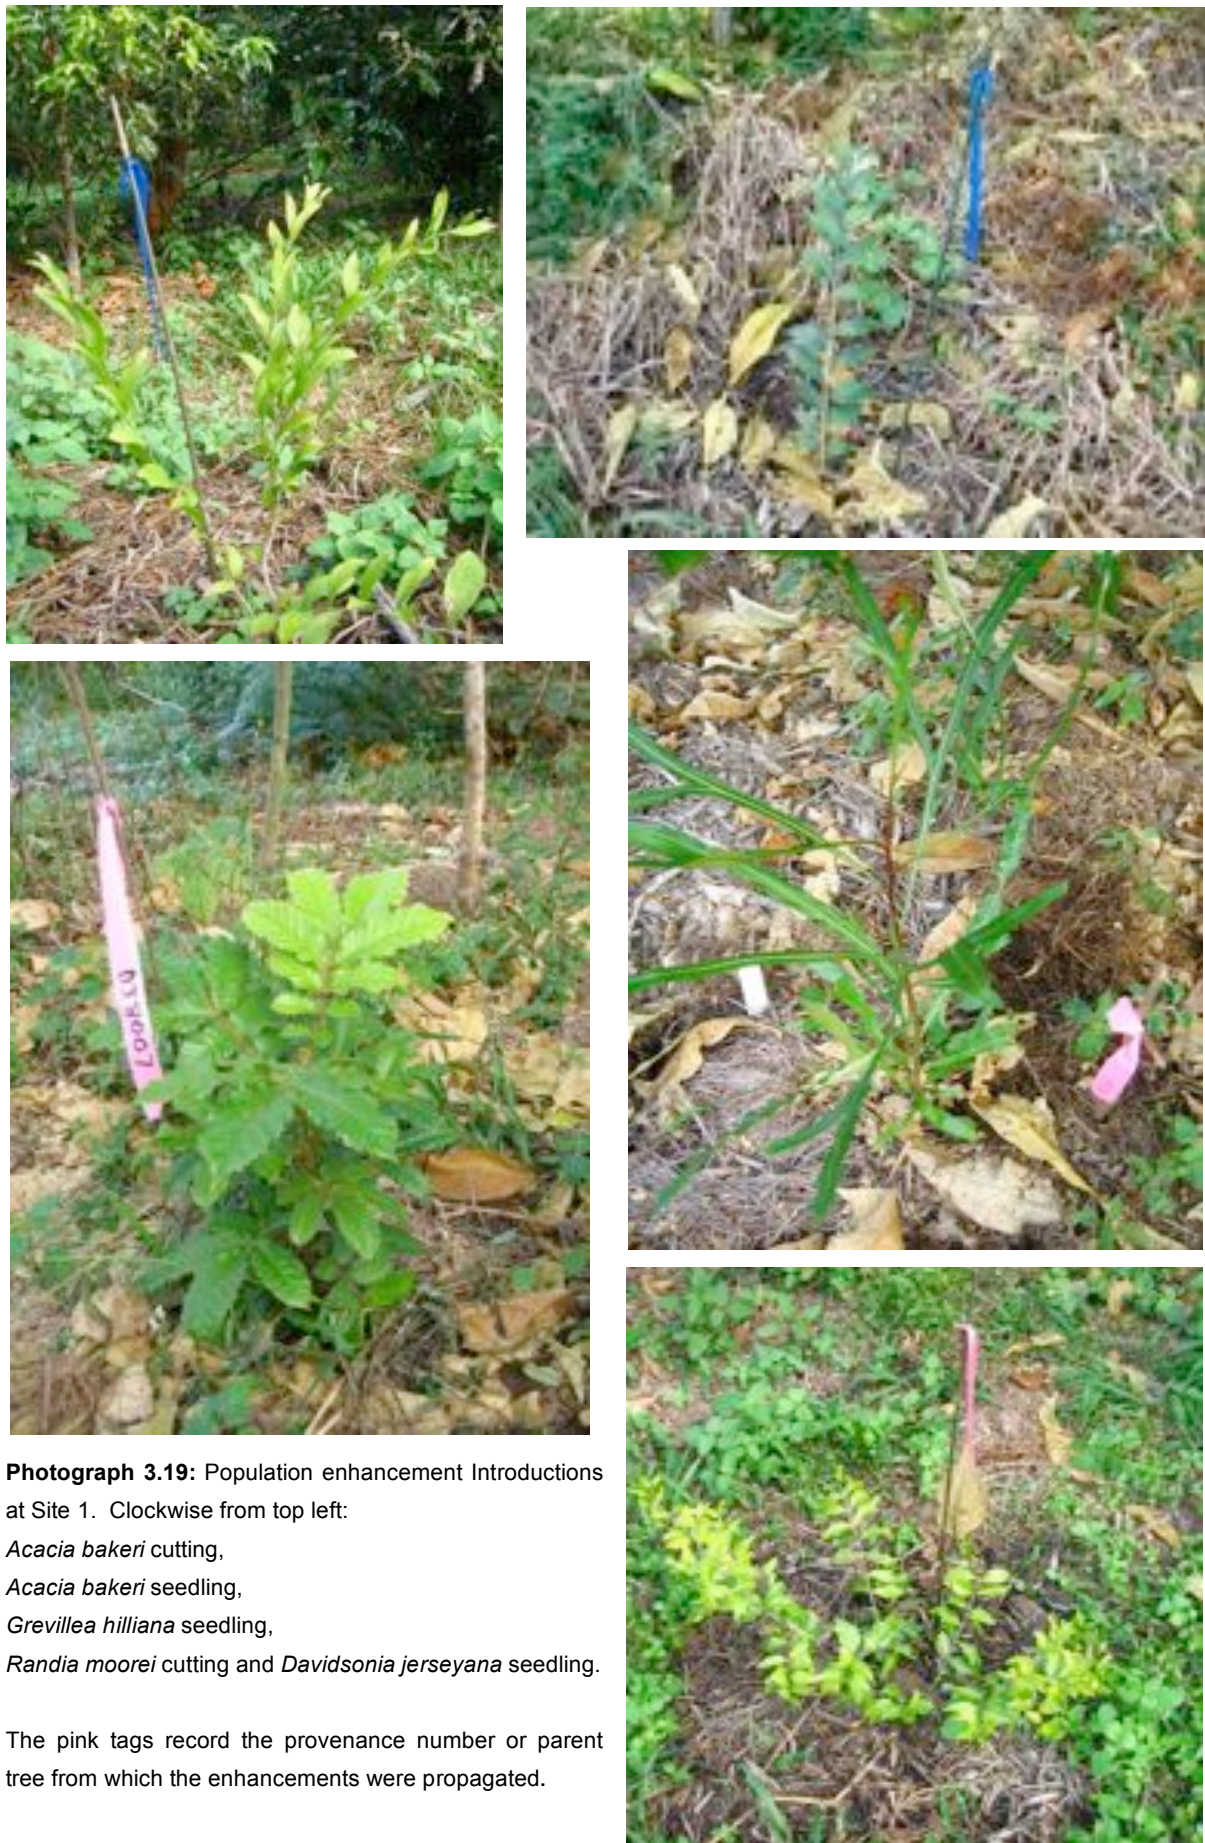
Photograph 3.19: Population enhancement Introductions at Site 1. Clockwise from top left:
Acacia bakeri cutting,
Acacia bakeri seedling,
Grevillea hilliana seedling,
Randia moorei cutting and *Davidsonia jerseyana* seedling.

The pink tags record the provenance number or parent tree from which the enhancements were propagated.

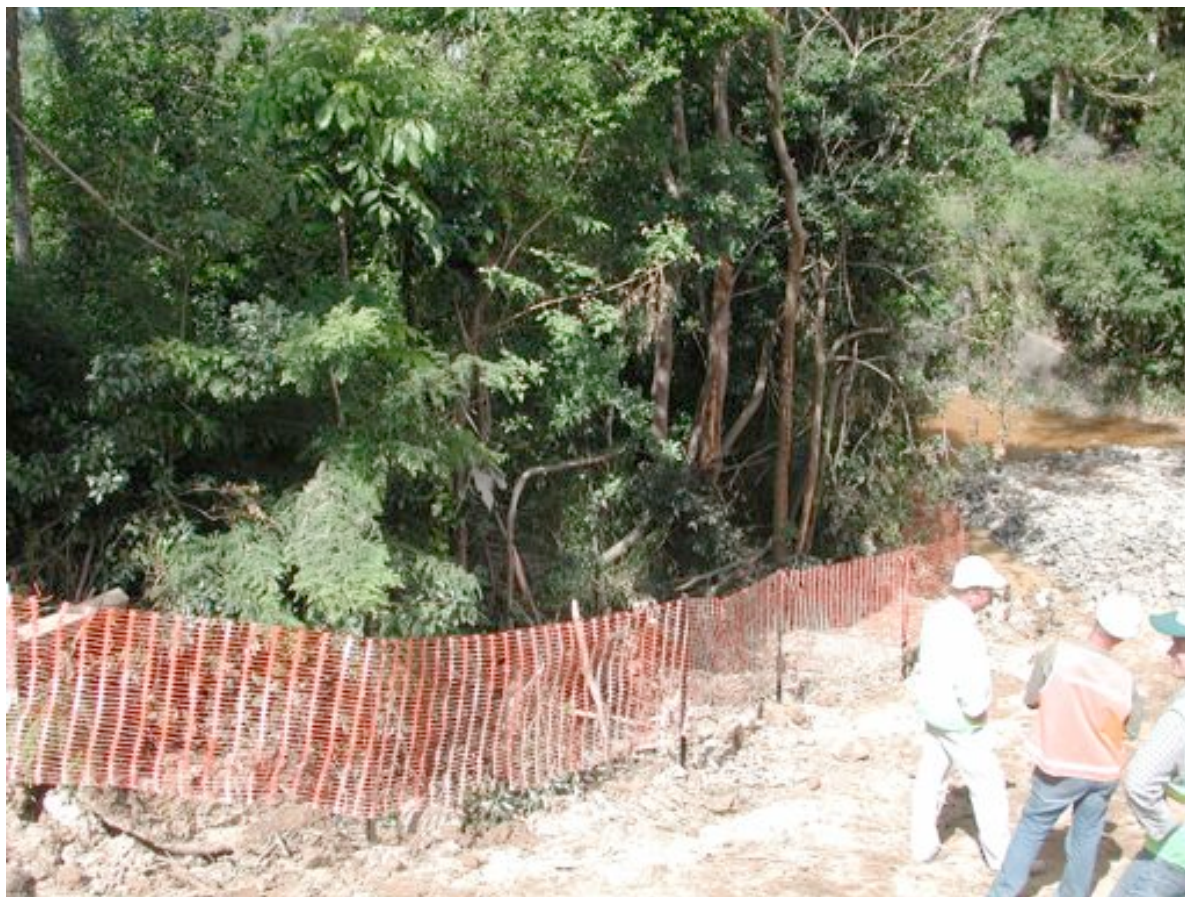
Photograph 3.20 'Paraweb' fencing delineating clearing zone.

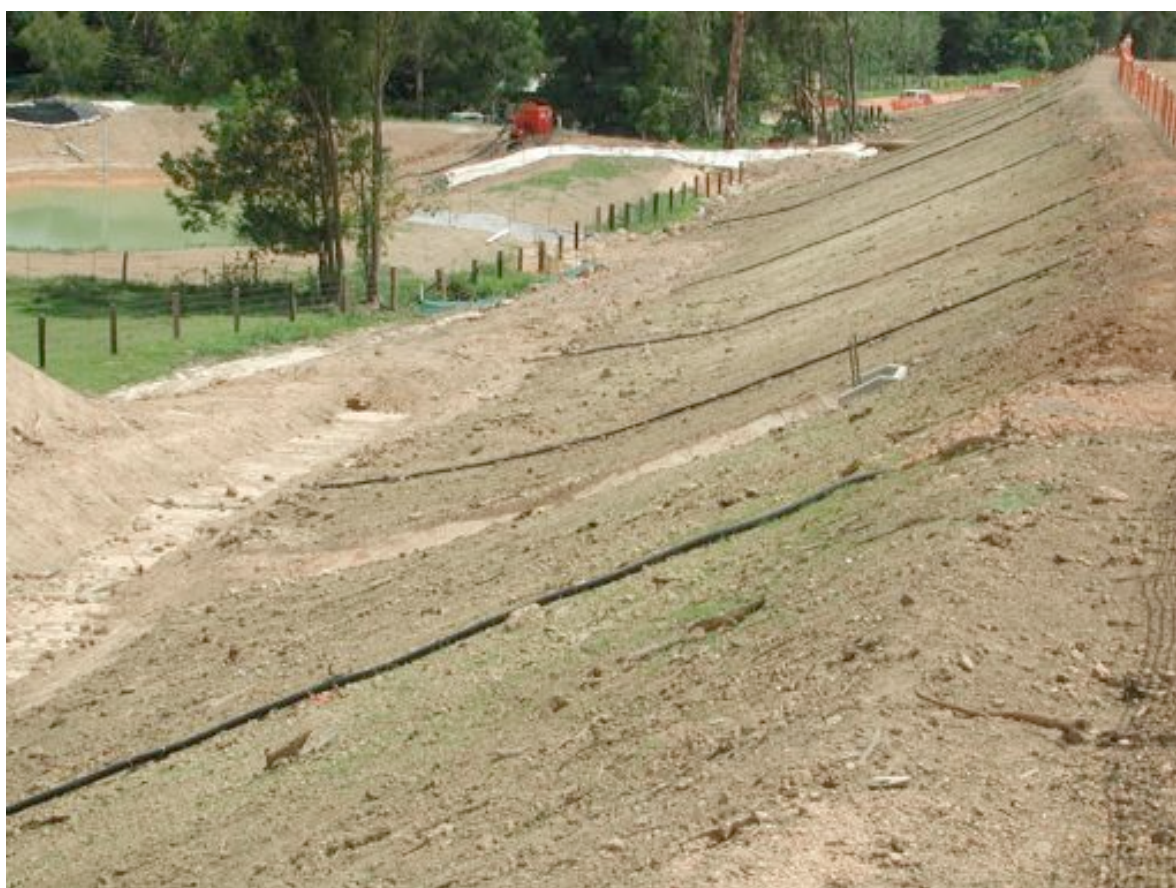
Photograph 3.21 Progressive revegetation was undertaken throughout the construction phase. This assisted with both erosion control and dust management.

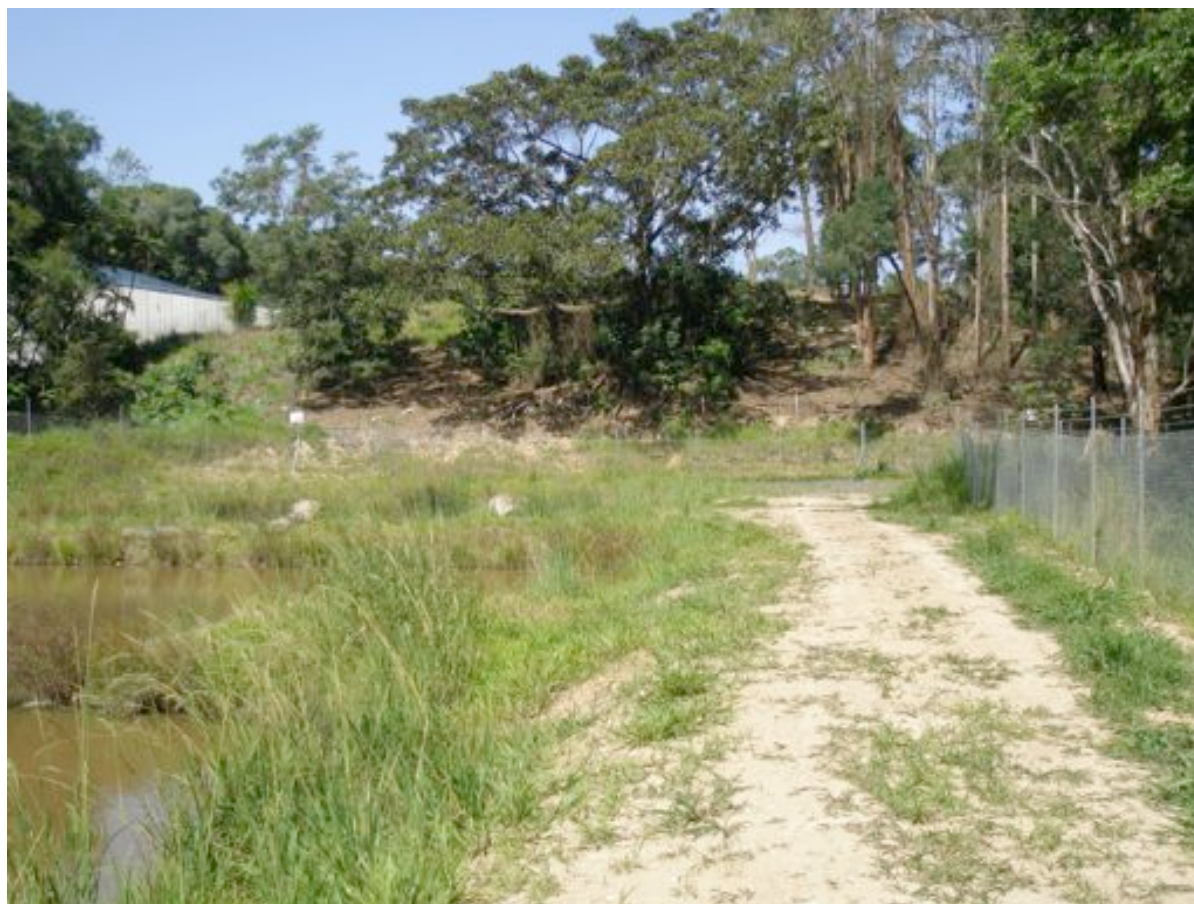
Photograph 3.22 The area between the back of Wetland B and the Upgrade was the subject of a significant weed removal programme to reduce edge effects upon nearby significant habitats.

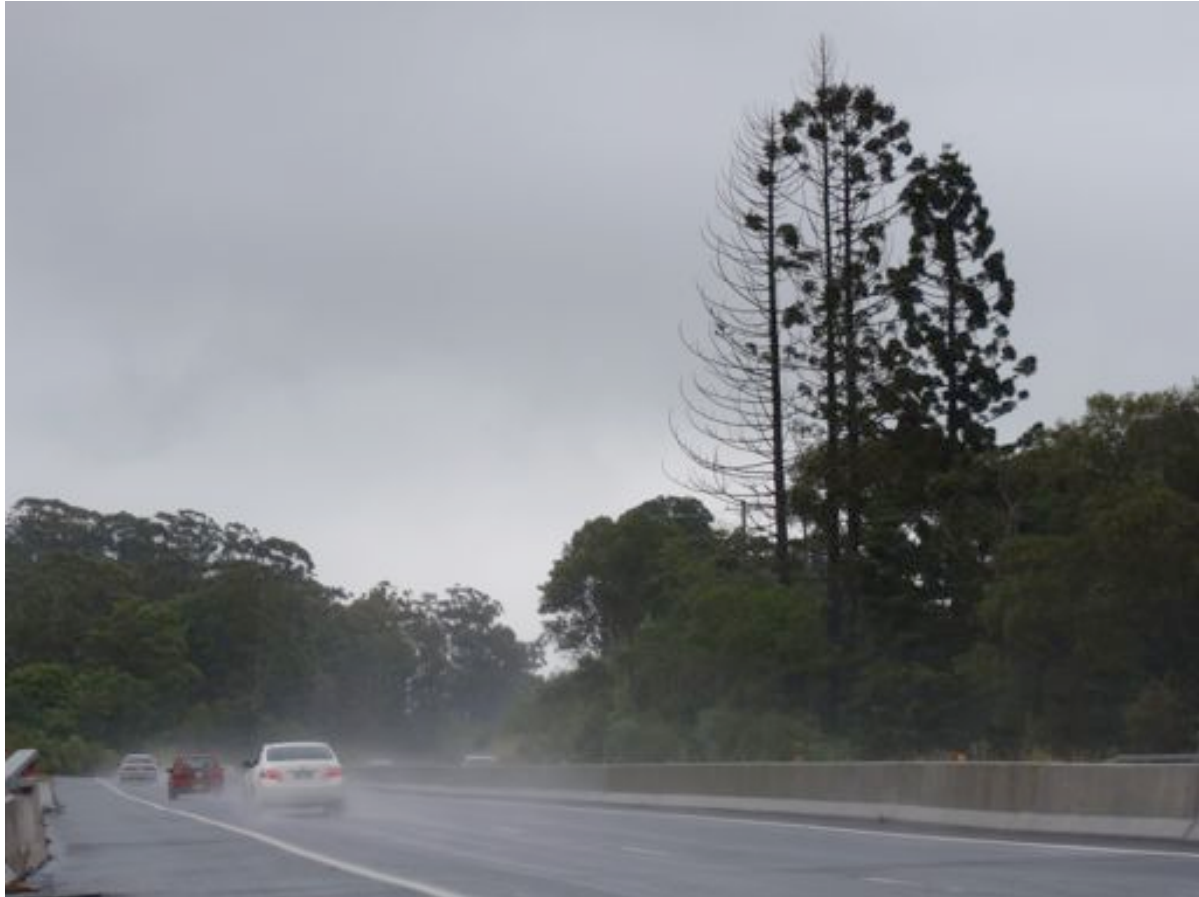
A number of trees in close proximity to the construction footprint have subsequently died, some more than 18 months following the completion of earthworks. These are found in both cut and fill areas and along the entire alignment. Both eucalypts and pine trees have been affected. This impact is common where soil disturbance occurs close to a tree, and is often associated with secondary infection following damage to the roots.

Photograph 3.23 Bunya Pines near the STP access Road. These, and a small number of other trees along the alignment died several years following the completion of earthworks, most likely due to soil disturbance in, or over, the root zone. These impacts are difficult to predict and the preferred approach is to leave the trees in place whenever possible, with the understanding that some will die, and have to be removed later.

Where trees are in close proximity to earthworks, consideration must be given to possible root damage due to soil disturbance, or through grade changes which may disturb the delicate relationship between roots and the surrounding soil. Consequences include root mortality, decline in vigor, and frequently, death of the tree. An arborist should be consulted early in the design and / or construction process with regard to treatment of the tree, changes to design which may limit such disturbance, or removal of the tree due to a low likelihood of survival.
