3.9 Geology and Soils

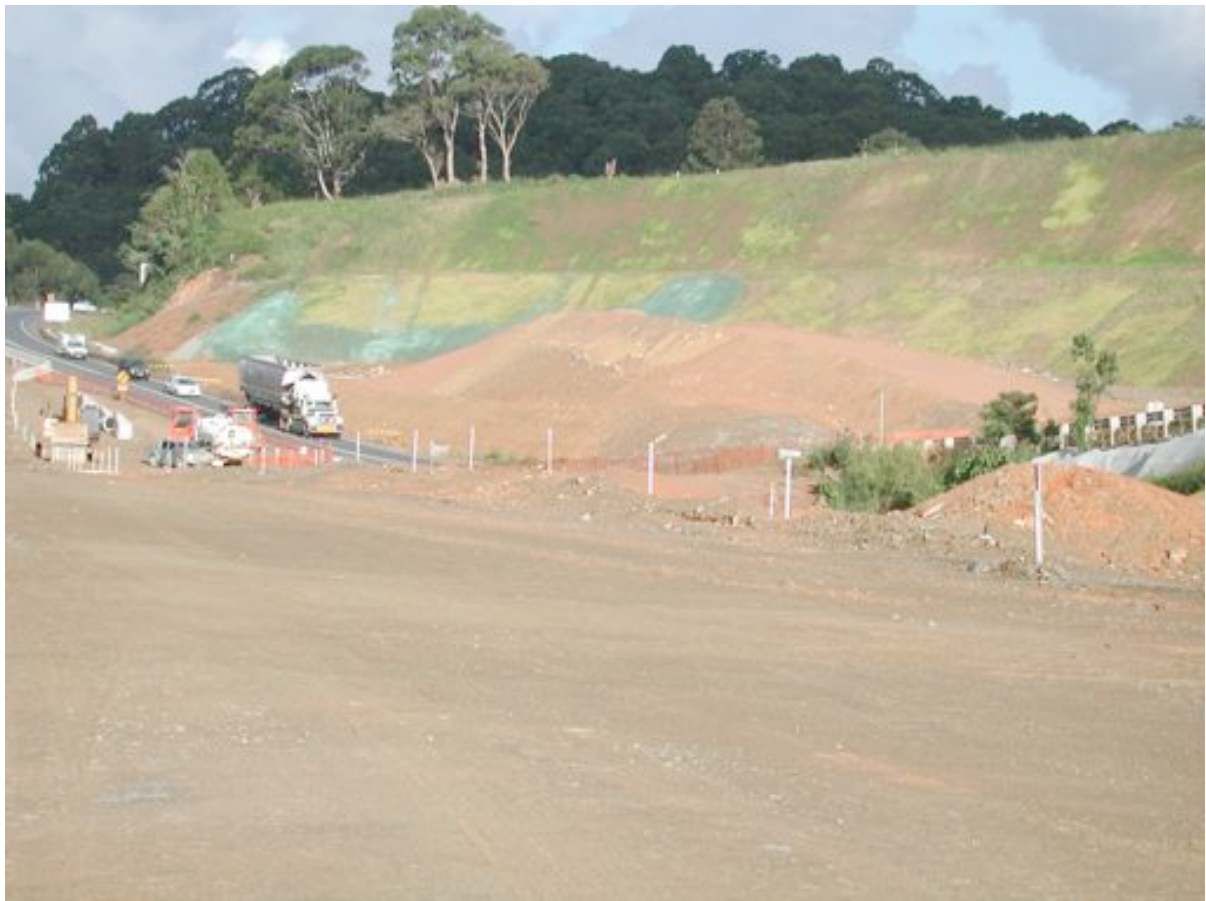
Photograph 3.33 Progressive stabilisation of batters at the Yelgun Rest Area.

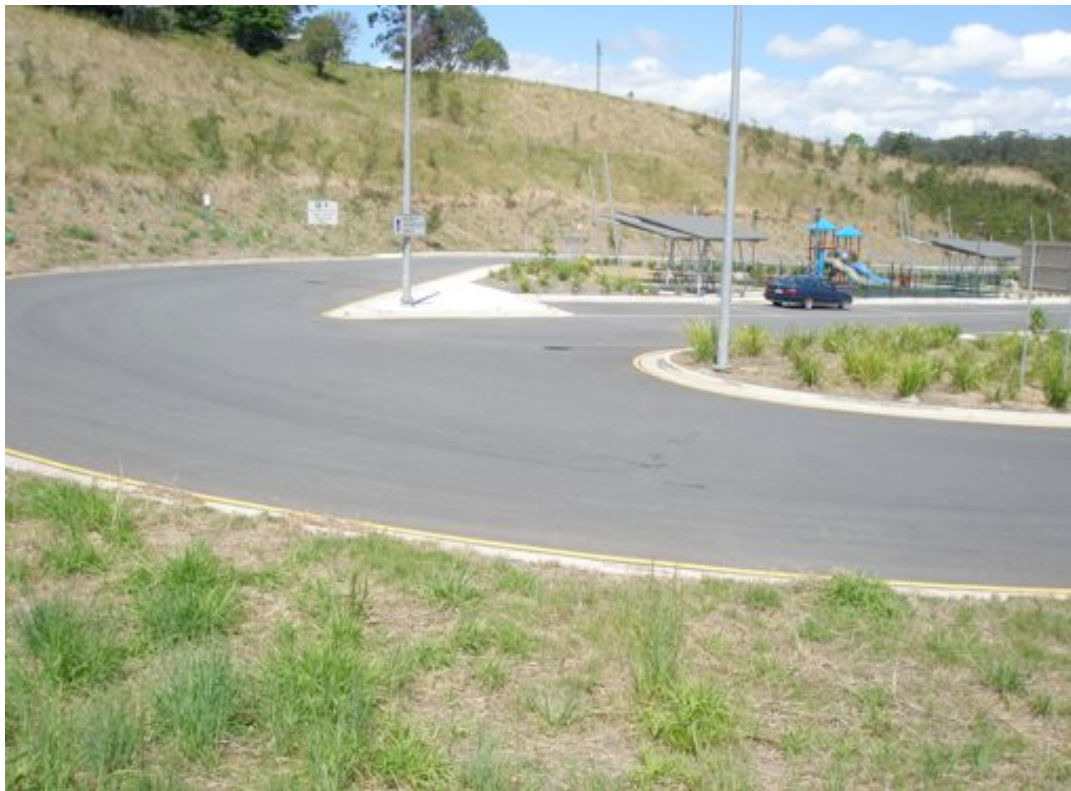
Photograph 3.34 The stabilised batters at the Yelgun Rest Area. The vegetation appears brown as a consequence of recent mowing.

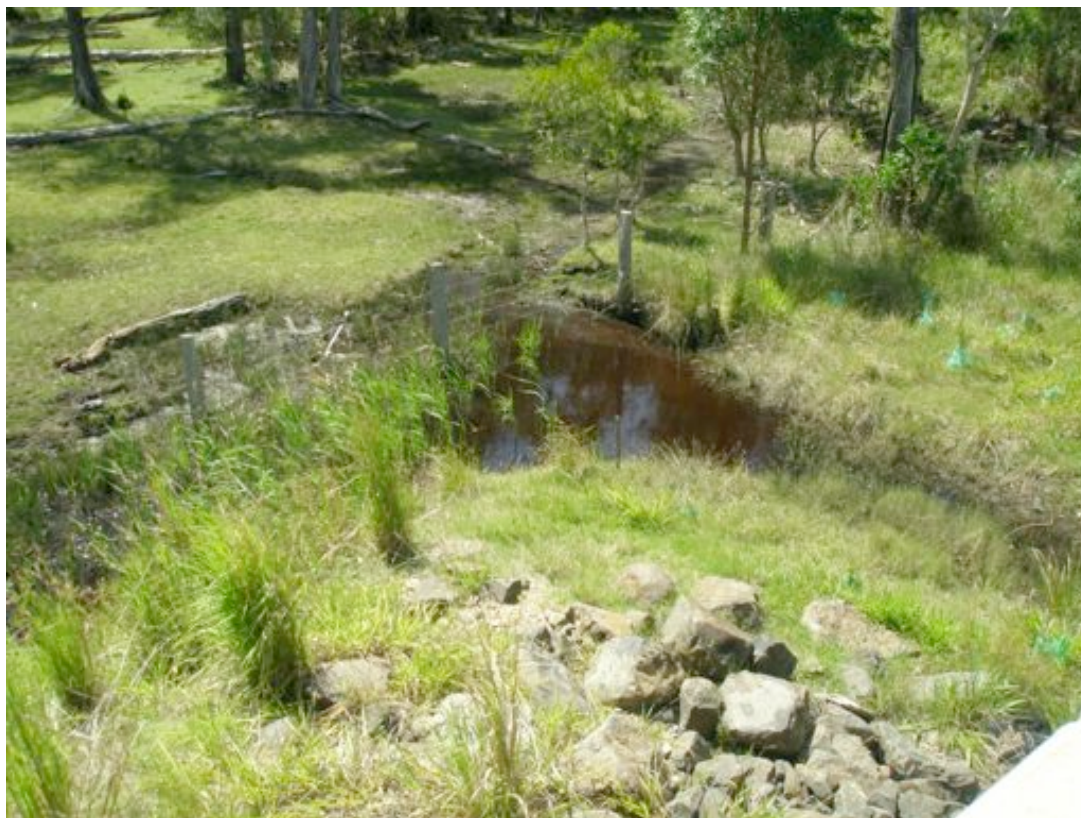
Photograph 3.35 Stabilised wetland at southern end of Upgrade.
