3.7 Fauna

3.7.1 Construction

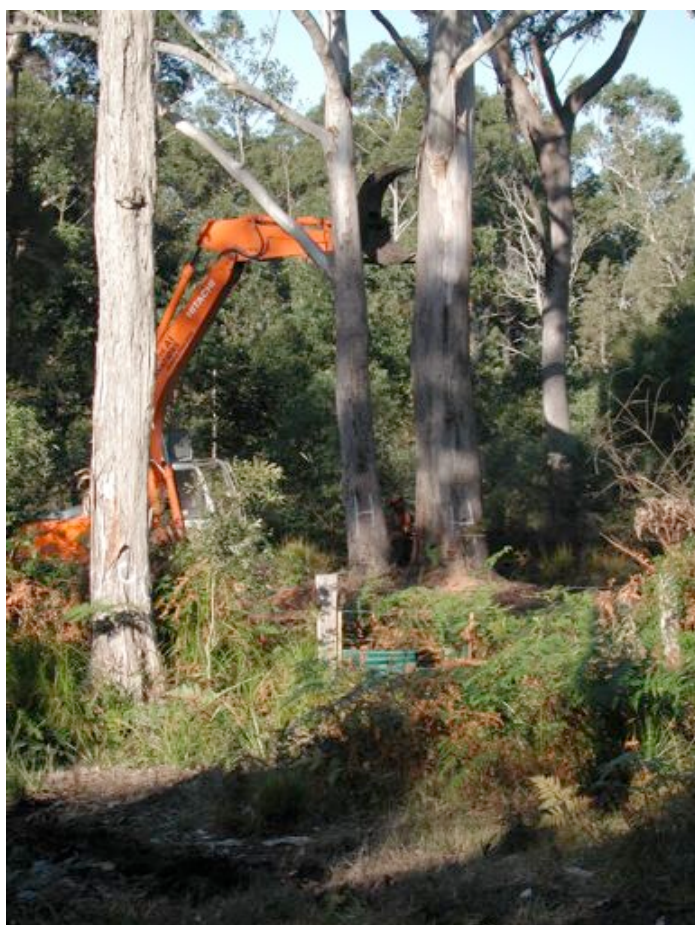
Photograph 3.24 Progressive clearing with habitat trees (marked with 'H' in photo) felled in the presence of a fauna specialist.

To minimise impacts to fauna, vegetation within the road footprint containing habitat characteristics was cleared in a two-stage process to reduce impacts on fauna. Habitat trees were selected on the basis that they comprised potential shelter sites for vertebrate fauna. Typically this was evident in the form of hollows visible in the tree trunk or branches. All such habitat trees along the alignment were marked and the surrounding trees were cleared to promote the natural relocation of animals.

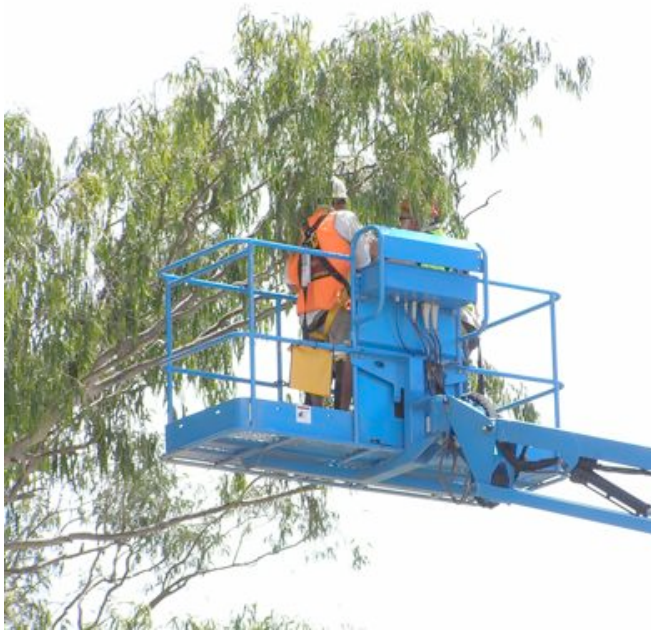
Photograph 3.25 Inspecting tree hollows with a cherry-picker for fauna prior to clearing

Before felling, habitat trees were first examined for the presence of any visible fauna. This was done in order to avoid operators felling a tree with vulnerable fauna in the canopy. In the single situation where live fauna were visible in a habitat tree; a mobile boom lift was used to remove the nestling Pied Currawongs from a Forest Red Gum near the Brunswick River. Once felled, habitat trees were inspected as soon as possible. The interior of any visible hollows was examined with a torch and following this, the canopy of the tree was inspected. Very few fauna were discovered in these hollows. Where fauna were detected, they were either captured by hand, or kept in the hollow (by stuffing the entrance with a cloth bag full of cloth bags).

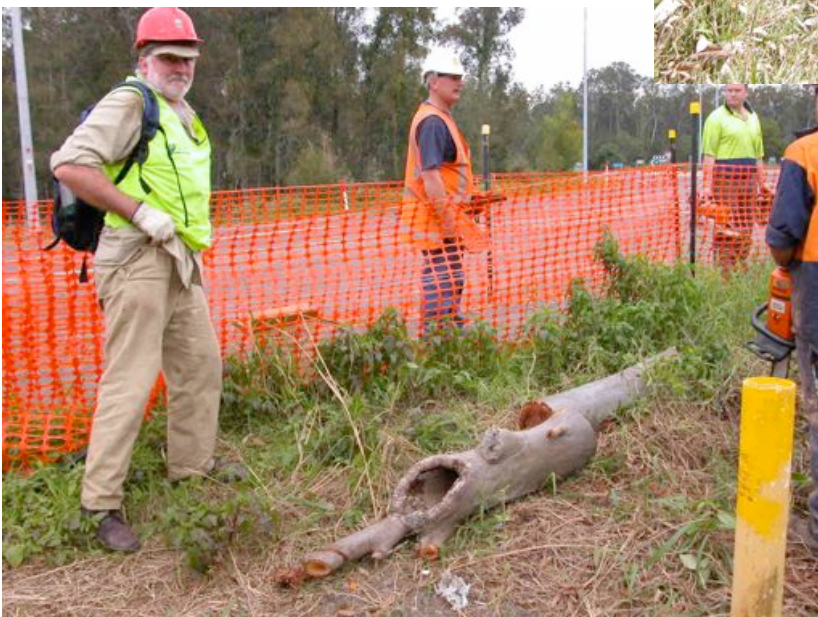
Photograph 3.27 Inspecting tree hollows with a cherry-picker for fauna prior to clearing

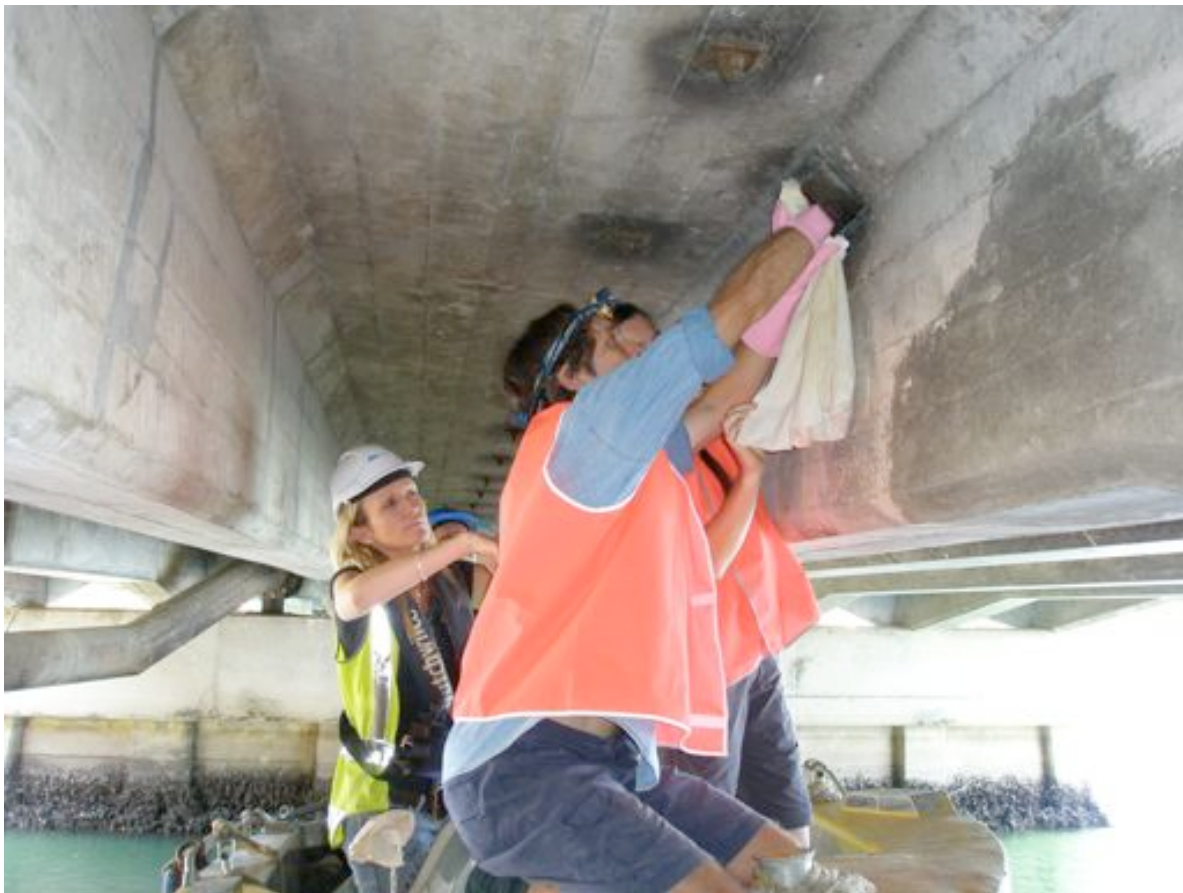
Photograph 3.28 Removal of fishing bats from scuppers in the old Brunswick River Bridge prior to demolition.

A pre-demolition fauna inspection of the Brunswick River Bridge by the project ecologist identified a roost of approximately 109 micro-bats (*Myotis adversus*) inhabiting the original scuppers of the bridge. *Myotis adversus* (fishing bat) is listed as a threatened species under the *Threatened Species Conservation Act 1995*. A specialist bat ecologist was engaged by the RTA to assist the project team with the translocation of the bat colony prior to bridge demolition. An independent specialist bat ecologist was also engaged by the RTA to undertake a peer review of the translocation methodology.

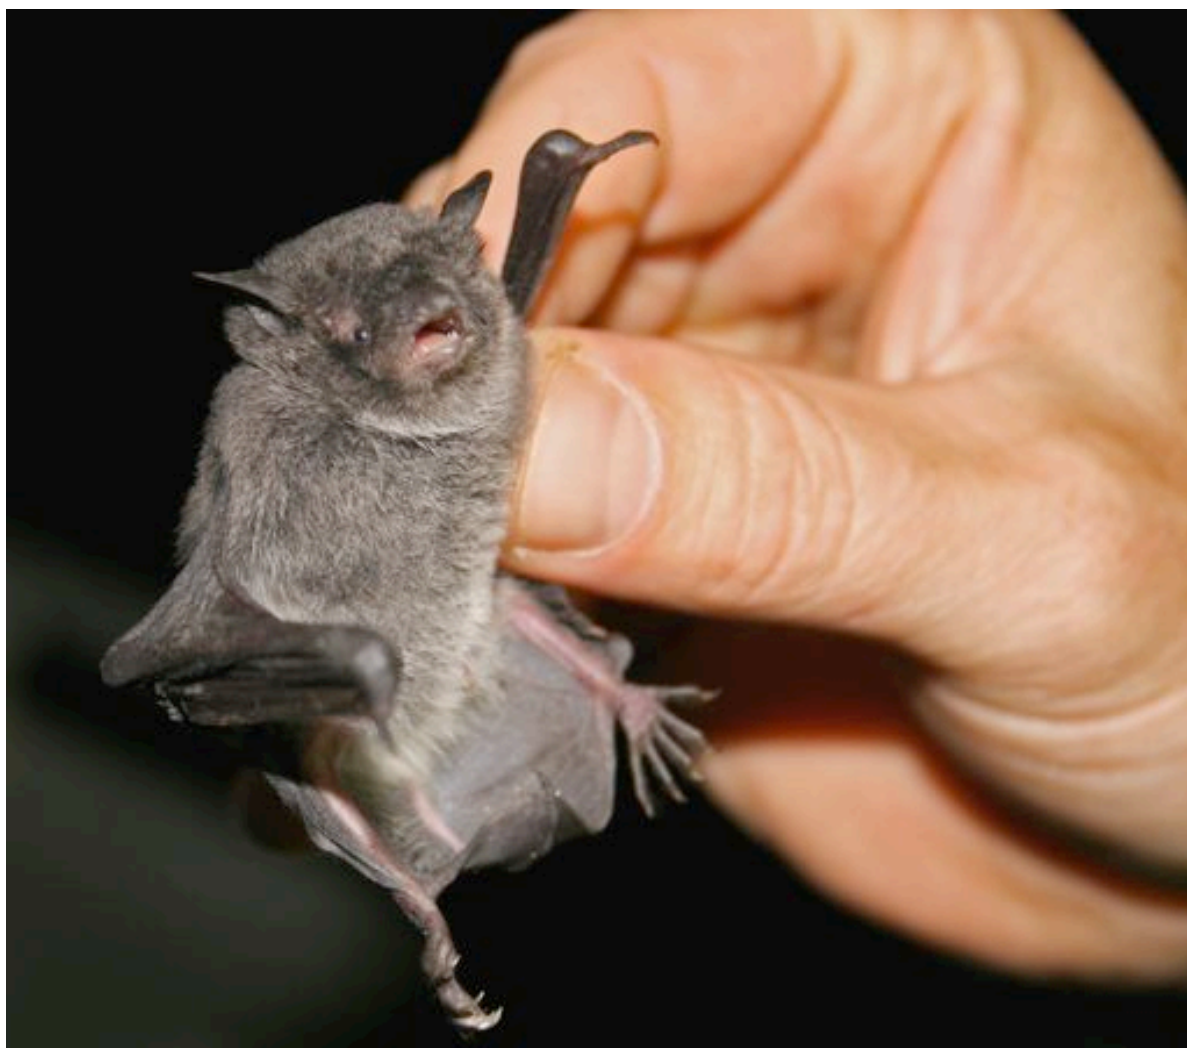
Photograph 3.29 A fishing bat removed from scuppers in old Brunswick River Bridge prior to demolition.

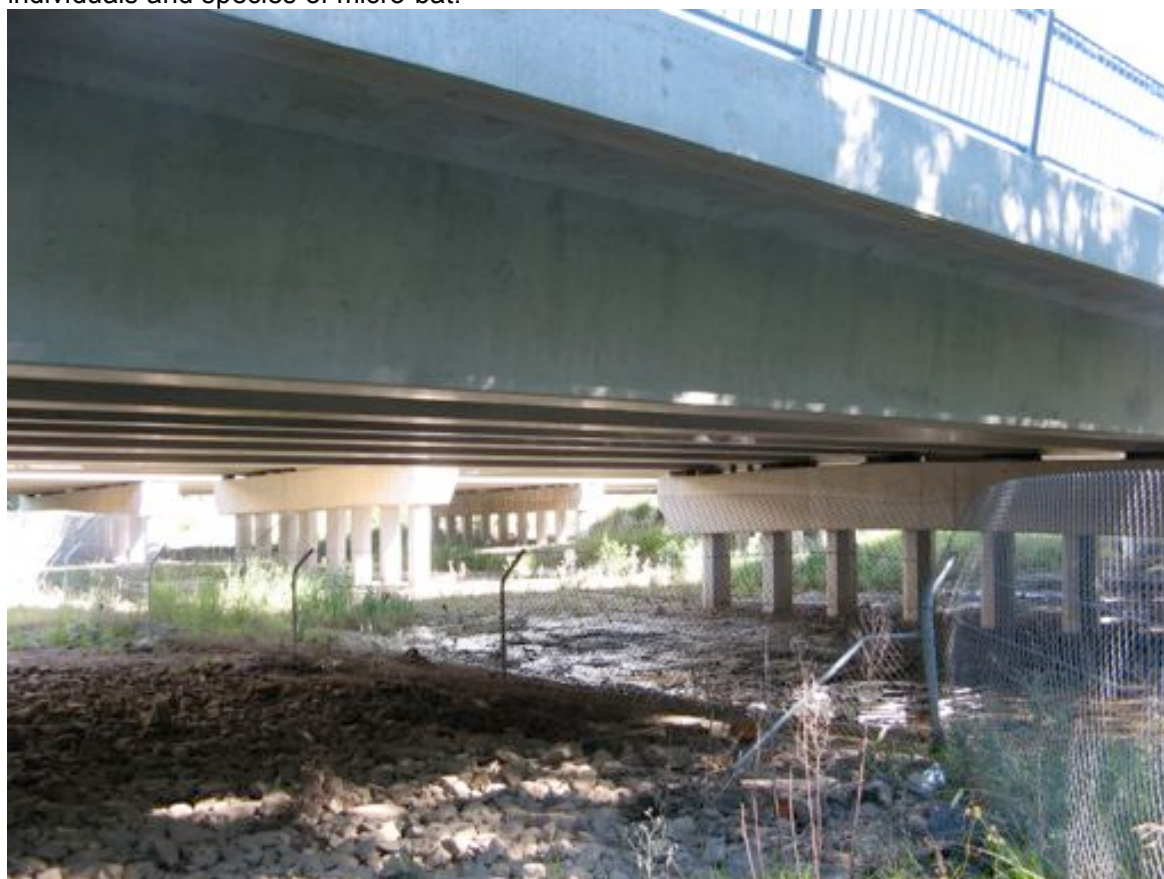
Figure 3.30 The Pacific Highway Road Bridge over Marshalls Creek, Billinudgel, local access road as viewed from the eastern edge of the southern abutment.

The Pacific Highway crossing of Marshalls Creek has three bridges each containing two lanes of traffic. Anabat recordings taken from beneath the southern abutment of the local access road on 7th May 2008 indicate moderate levels of microbat activity at this location. Over 100 bat passes were recorded, with 64% identified as *M. adversus*. Activity patterns clearly show the emergence and return of *M. adversus* to roost, as well as a significant number of Eastern Horseshoe Bat calls indicating use of the abutment as a foraging area and feeding perch (Photograph 3.29.).
