3.8 Compensatory habitat

3.8.1 Mangrove Compensatory Areas

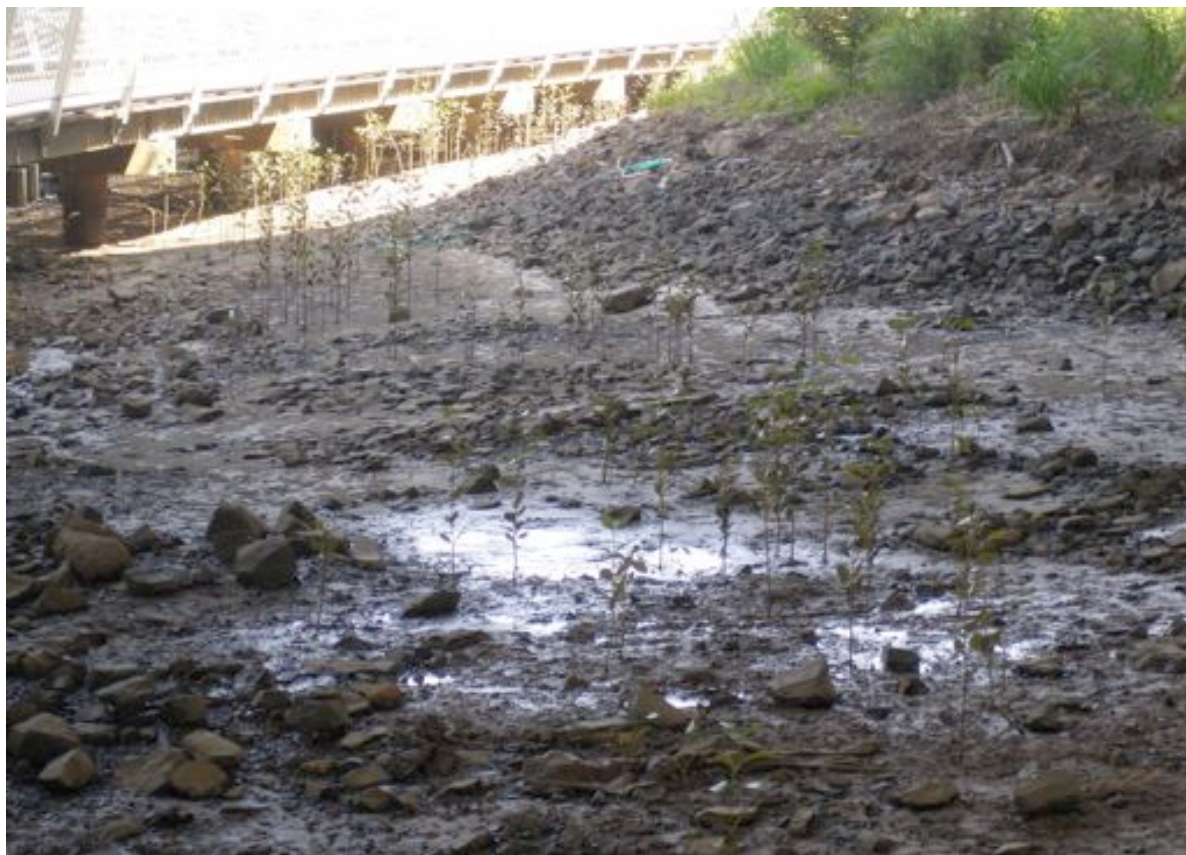
If inside a SEPP14 Wetland, ratio of 10:1 was to be achieved, otherwise a ratio of 2:1 was required. Replanting of mangroves was performed, and there is also evidence of natural re-establishment under the bridge on the southern bank (Refer to Photograph 3.31). Some of the land purchased by RTA also had wetlands.

Photograph 3.31 Natural re-establishment of mangroves on the southern shore of the Brunswick River under the new bridge.

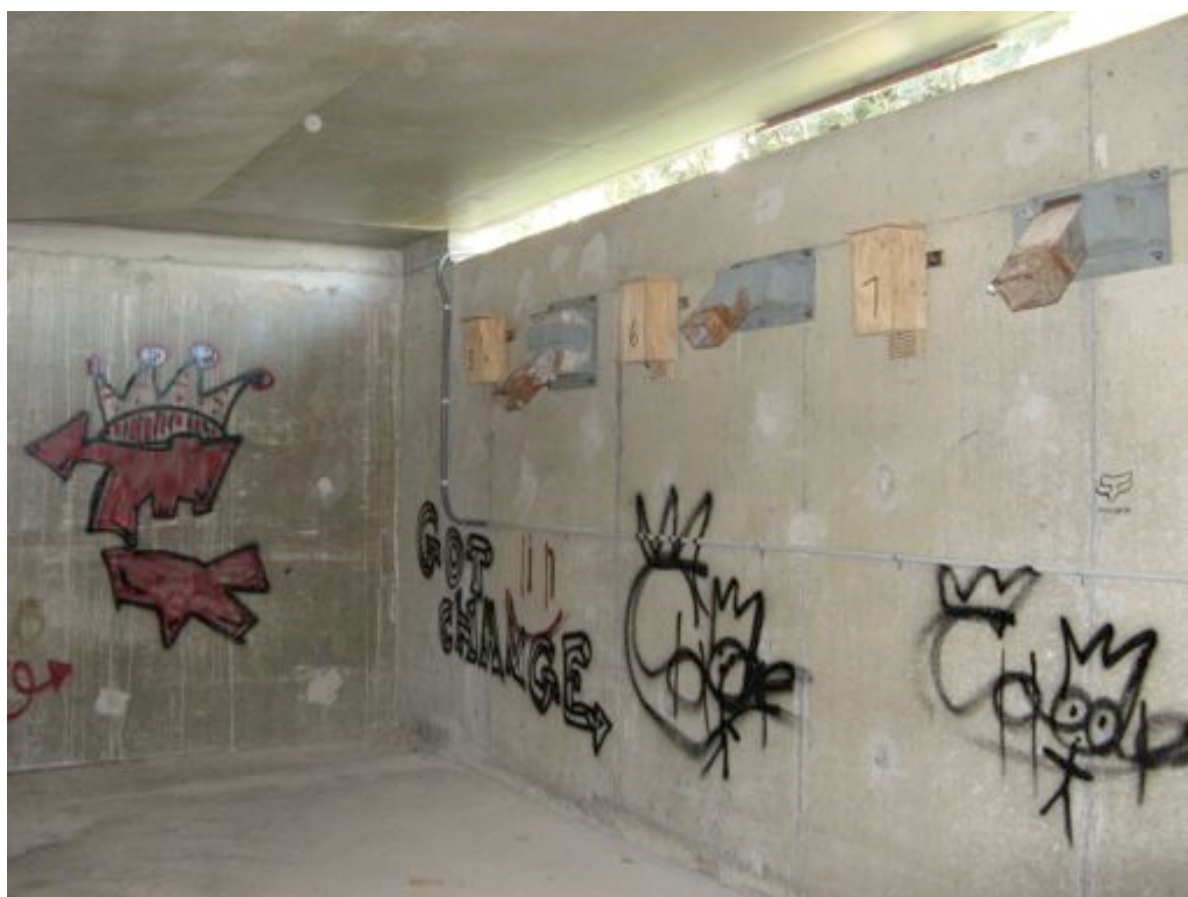
Despite efforts by the RTA to improve the security of the northern abutment, the area remains unsuitable for sustained habitation by micro-bats due to the continued human disturbance within this abutment (Photograph 3.32). During the May 2008 site inspections it was found that

unauthorised access was also a problem in the southern abutment with graffiti sprayed on internal abutment walls. Bat friendly gating and barbed wire fencing (away from the bat entry point) have been discussed as a method of securing the abutments and plans to secure both abutments are currently being developed by the RTA in collaboration with ELA ecologists. The barbed wire fencing has subsequently been installed.

Photograph 3.32 The northern abutment of the Brunswick River Bridge showing the graffiti that has been produced by persons entering the abutment illegally. This activity may also have impacted upon the use of the boxes which are visible on the right-hand wall.
